**ON THE**  
**SERVICE LIFE MODELLING**  
**OF**  
**TASMANIAN CONCRETE BRIDGES**

Submitted in fulfilment of  
the requirements for the Degree of  
Doctor of Philosophy

University of Tasmania

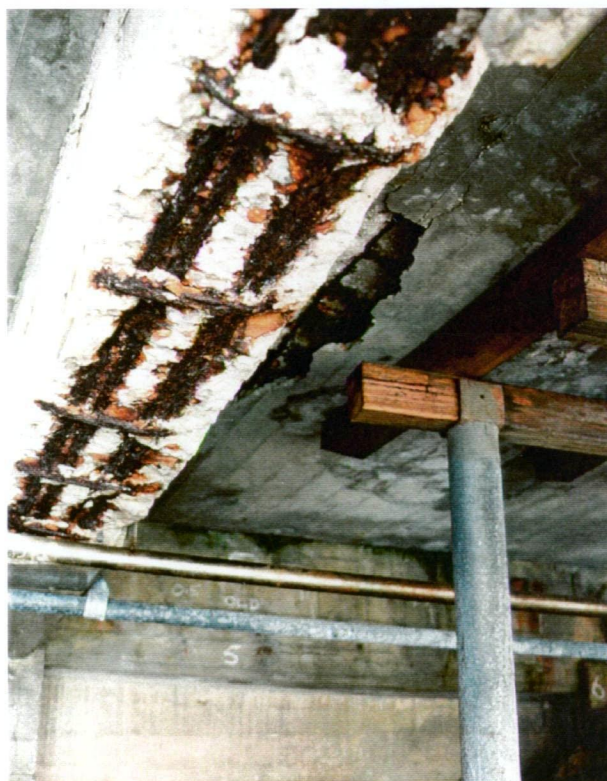
**Figure 4.7 - Stanley Dock beam and slab**

The systematic inspection program established by the author had identified a number of structures affected to varying degrees by one or more of the various forms of concrete deterioration. Figure 4.7 shows a severe case of chloride induced corrosion of a wharf structure which has resulted in delamination and spalling of cover concrete on both beams and deck slab soffits and significant loss of section of reinforcing steel. Scaffolding in the background of the photograph is supporting the delaminated deck slab soffit cover concrete for reasons of public safety.

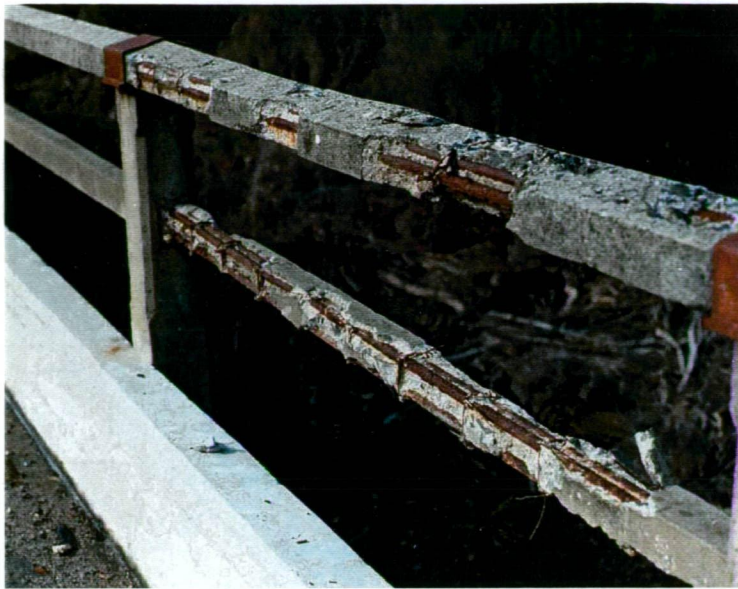
**Figure 7.10 – Carbonation induced corrosion damage to structure**

While the frequency and severity of carbonation damage in Tasmanian bridges is less than for chloride induced deterioration, there is nevertheless a number of cases where damage has occurred. The damage commonly occurs in concrete bridge railings where low and variable covers to reinforcement are common.

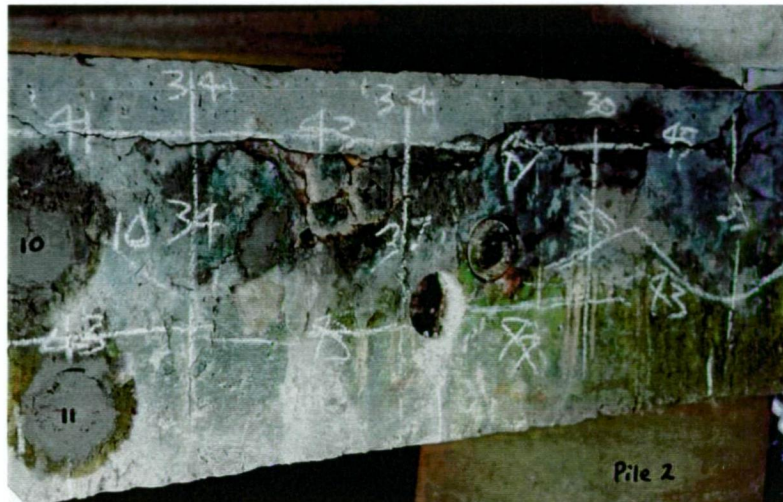
**Figure A3.1 – Cracking of Peggs Creek Bridge pier crosshead**

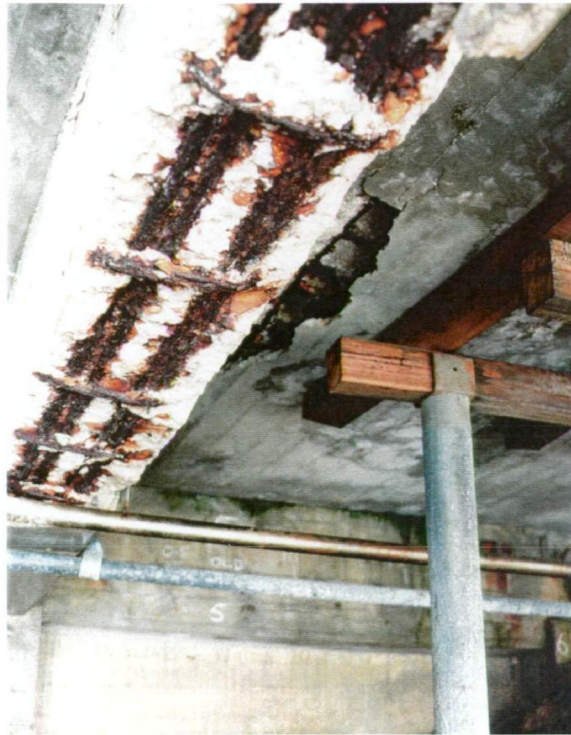
**Figure A3.2 - Stanley Dock beam and slab**

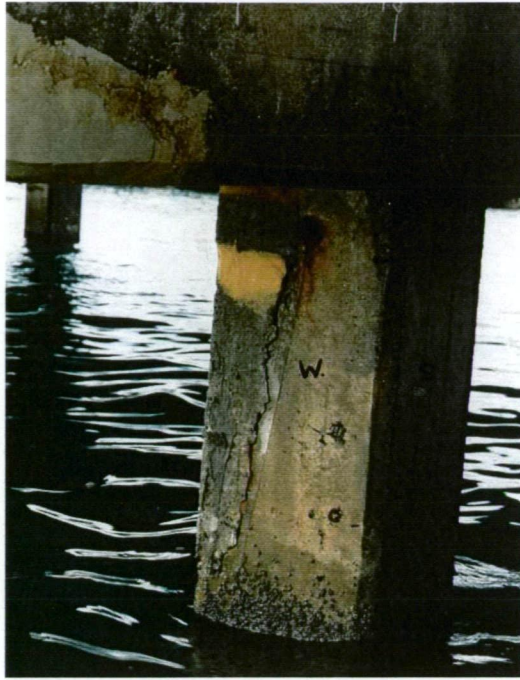
**Figure A3.5 – Cracking of Golden Fleece Bridge pile**

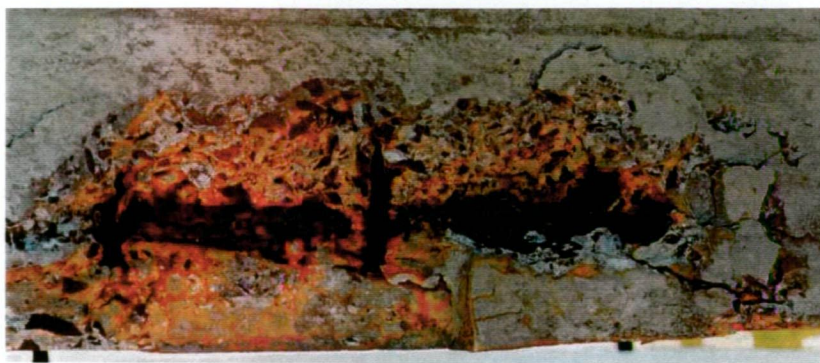
**Figure A3.6 – Corrosion of Wrinklers Bridge superstructure**

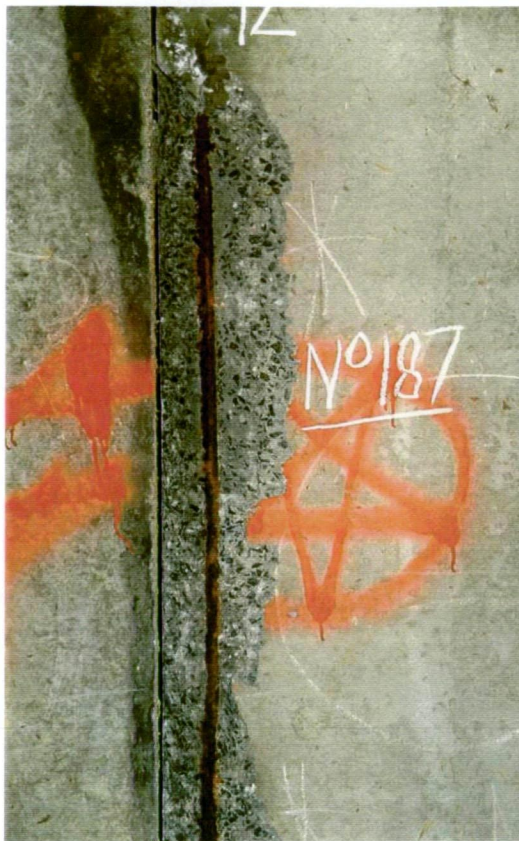
**Figure A3.7 - Spalling of Huon Highway Underpass crown units**

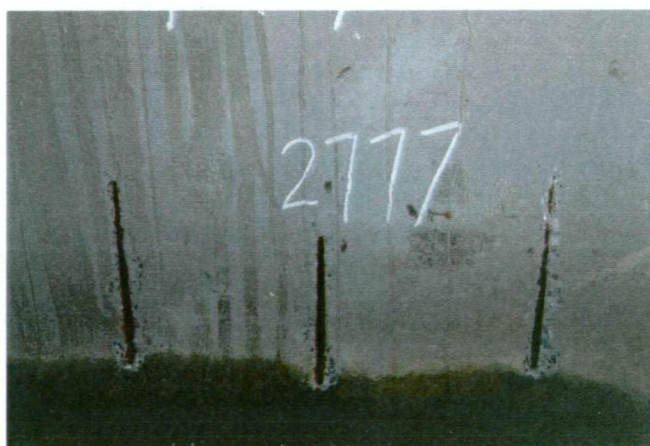
**Figure A3.9 – Spalling of Cusicks Creek Culvert crown units**
